**Subject: Addendum to Phase I Environmental Site Assessment**  
**APN 007-315-04**  
**427 Evans Avenue**  
**Reno, Nevada**

## SITE MAP

PHASE I ESA ADDENDUM  
427 EVANS AVENUE  
RENO, NEVADA 89501

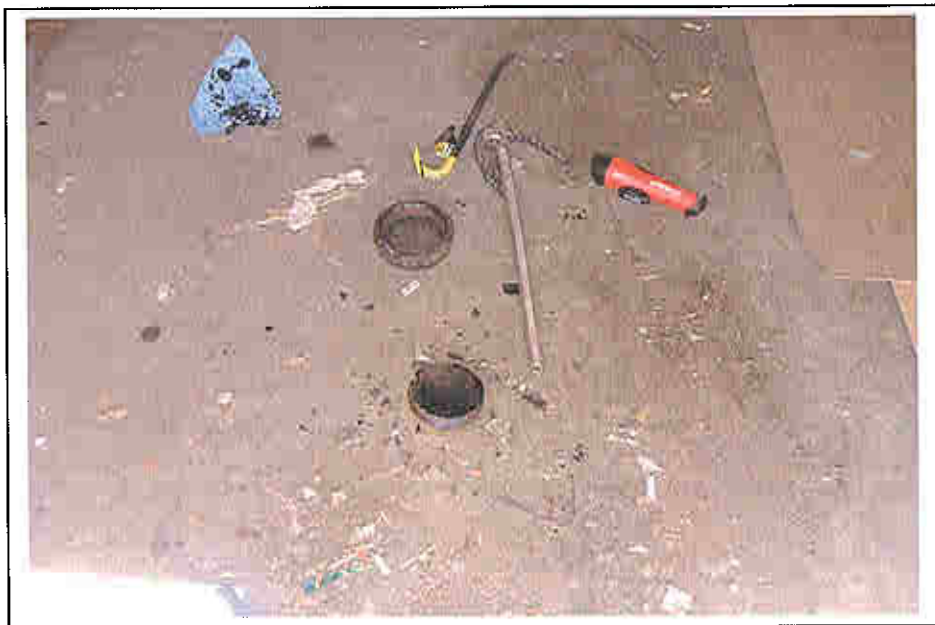
Nevada Underground Location (NUL) performed a subsurface metallic survey in the vicinity of the fill ports. Based on the results of the survey, an apparently out-of-use heating oil UST is located under the building. The piping from the external (remote) fill port connects to the fill port in the garage, and the UST is located beneath the internal port. The bottom of the tank is approximately 10.5 feet beneath the concrete floor. The tank has a diameter of 5 feet, and approximately 8 inches of old heating oil remains inside. The orientation and exact dimensions of the tank could not be delineated, since metallic materials in the structure walls interfered with the survey equipment. It was also determined that a vent pipe seen on the roof of the building is associated with this UST.

The additional field investigation conducted on June 15, 2006, confirmed the presence of a heating-oil UST beneath the structure located on the subject site. It is 5-feet in diameter, but the length, capacity, and orientation could not be determined. A small amount of oil is present in the UST.

Fill port and UST  
location, in garage.

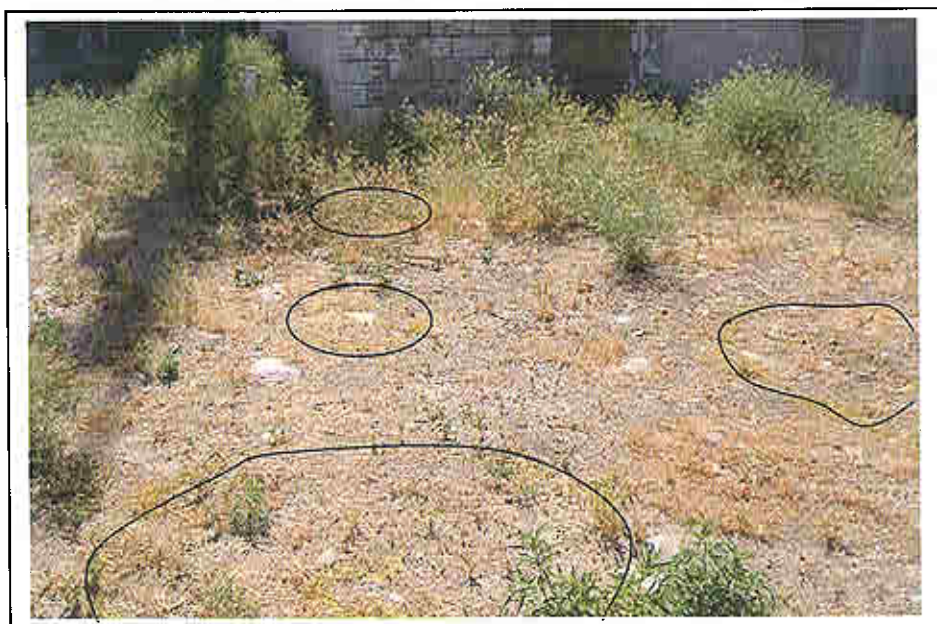
A magnetic survey was also conducted outside of the building, in the area of the former UST's identified in the Phase I ESA. A total of four subsurface metallic anomalies were identified near the southeast corner of the structure. They were relatively small in size, with the largest being approximately 3 feet in diameter. None of these subsurface anomalies appears to be the UST formerly located in the vicinity. The approximate locations of the fill ports, UST, vent pipe, and subsurface metallic anomalies are shown on Plate 1, and photographs taken during the survey are shown on Plates 2 and 3.

Subsurface metallic  
anomalies, southeast  
of structure.

Subsurface metallic anomalies were identified to the southeast of the structure, in the former UST area. Although they did not appear to be UST's, it may be beneficial to excavate this area in order to confirm the nature of these anomalies.

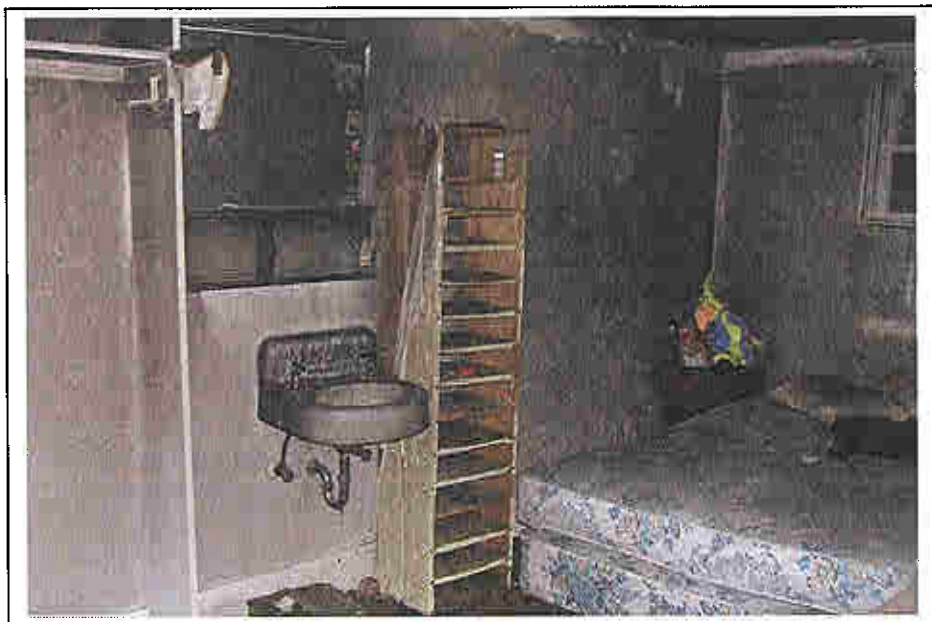
On June 15, 2006, Kleinfelder obtained access to the previously inaccessible portion of the structure on the subject site. This portion of the structure consisted of a living space and two separate one-car garage spaces at the north end of the building. The living space showed evidence of fire damage, and the northernmost garage space contained an abandoned car. The previously identified four-inch port is located near the garage doors at the northwest end of the building. A second four-inch port was found inside the southern garage space.

Interior living space.

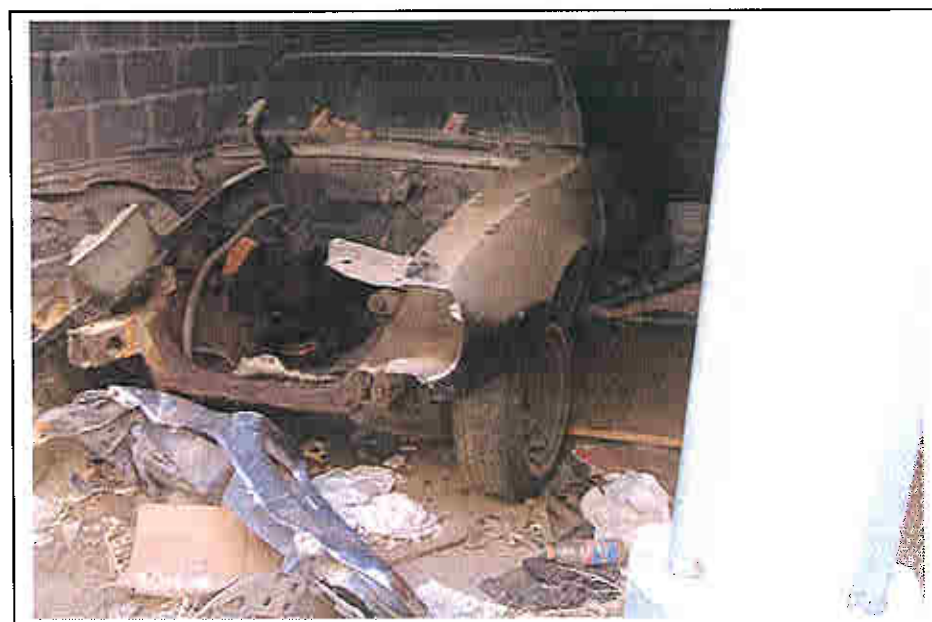
Northern garage space.
